Manhole Inspection Summary

Manhole # S45E__032MH

Insp Date: **7/23/08 8:47 AM**

Location Address: **1747 S Ann St**

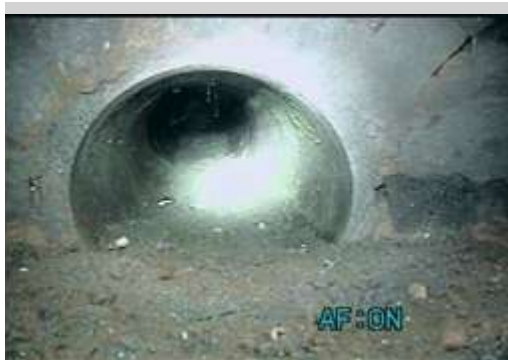
Defect 4

Condition: ☐ Sound ☐ Cracked ☐ Root Intrusion ☐ Deteriorated ☐ Leaks ☒ **Debris**

channel debris

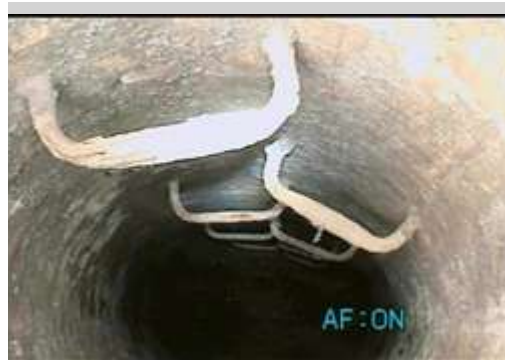
Defect 3

Count: **8** Missing: **0** ☒ **Corroded**

steps

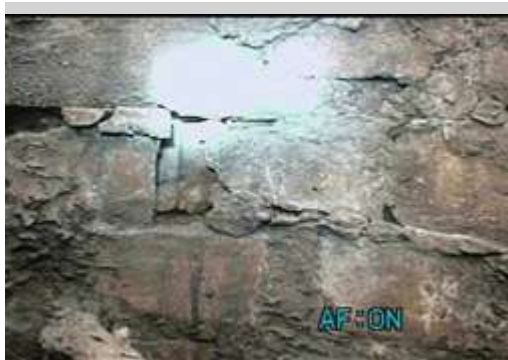
Defect 2

Condition: ☐ Sound ☒ **Cracked** ☐ Root Intrusion ☐ Loose Brick ☐ Deteriorated

corbel

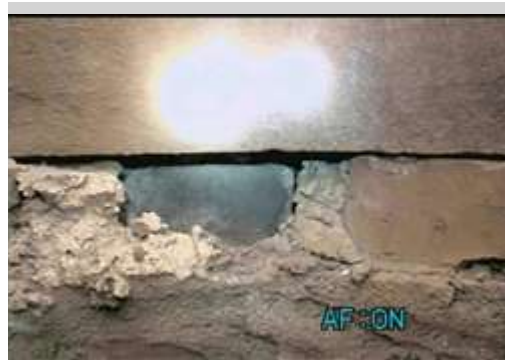
Defect 1

Condition: ☐ Sound ☒ **Cracked** ☐ Root Intrusion ☒ **Loose Brick** ☐ Deteriorated

cracked, loose bricks, frame adjustment
